31.12.2007

20 route du Val St. Pierre
76780 Croisy sur Andelle

1. ANALYSE GEBÄUDE

AXEL WELLER

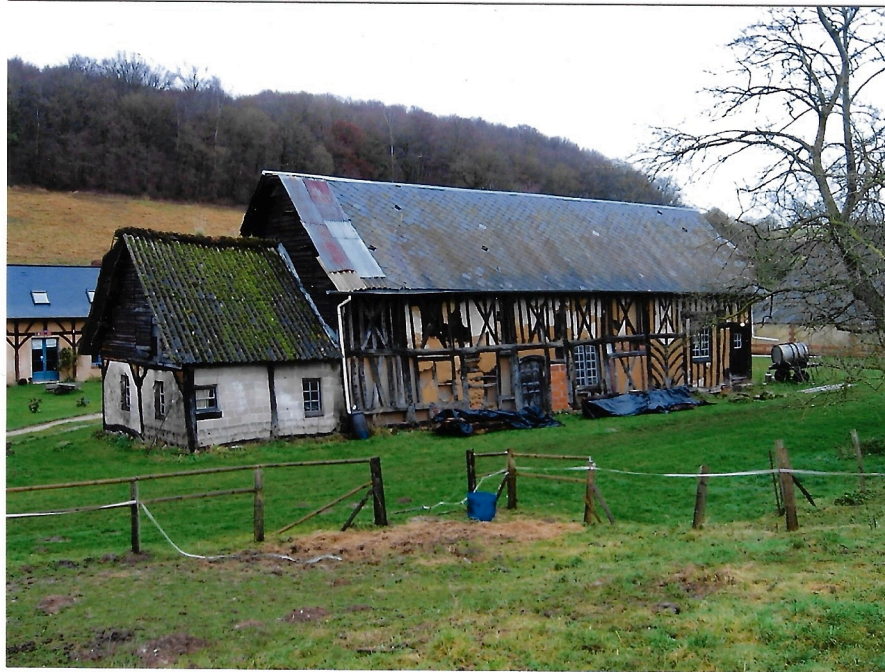
hofabgewandte Seite

THE SIDE AWAY FROM THE COURTYARD

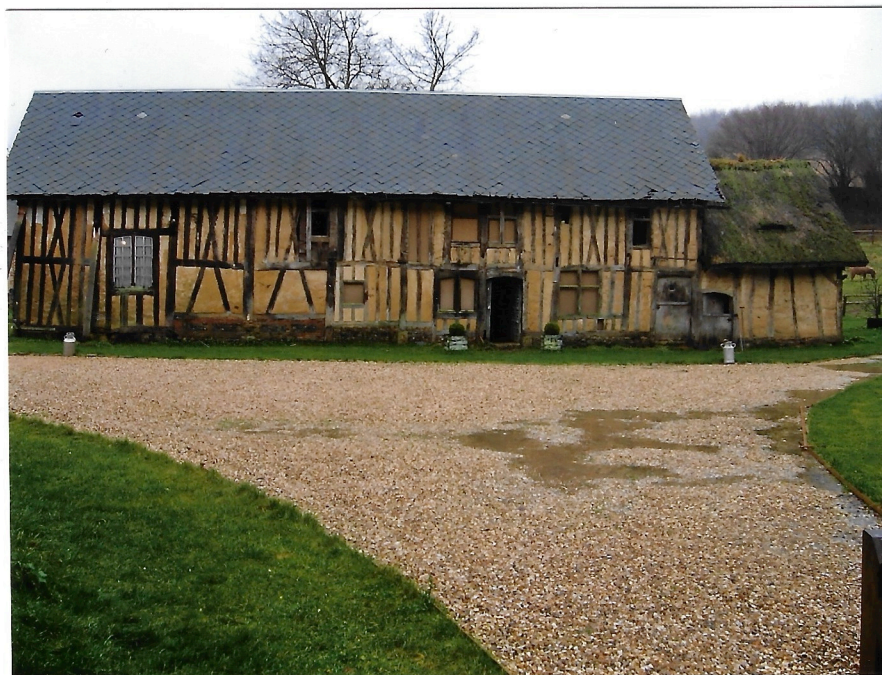
hofzugewandte Seite

THE COURTYARD-FACING SIDE

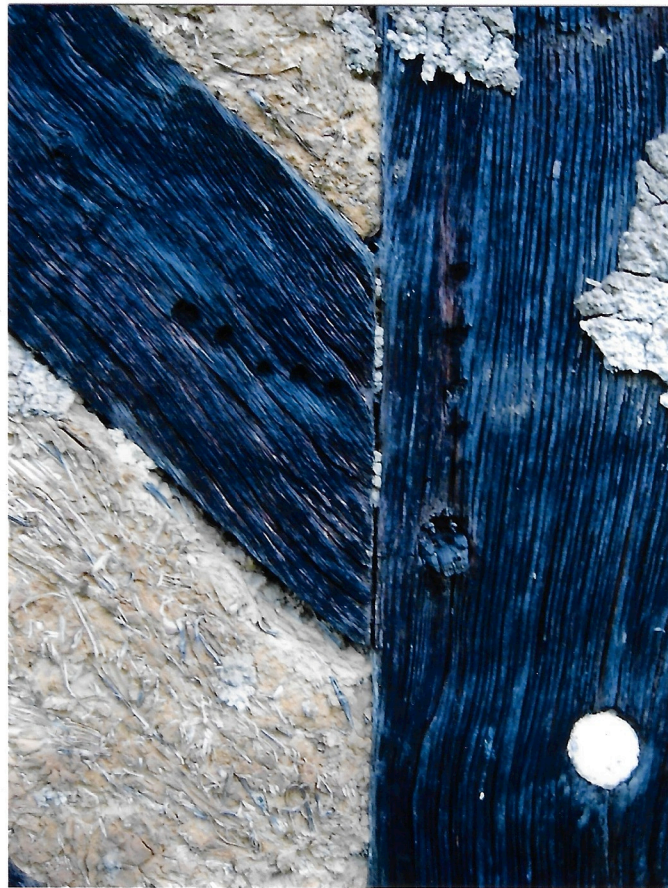
Markierung an der hofabgewandten Seite

Marking off the wood, the opposites of the courtyard site

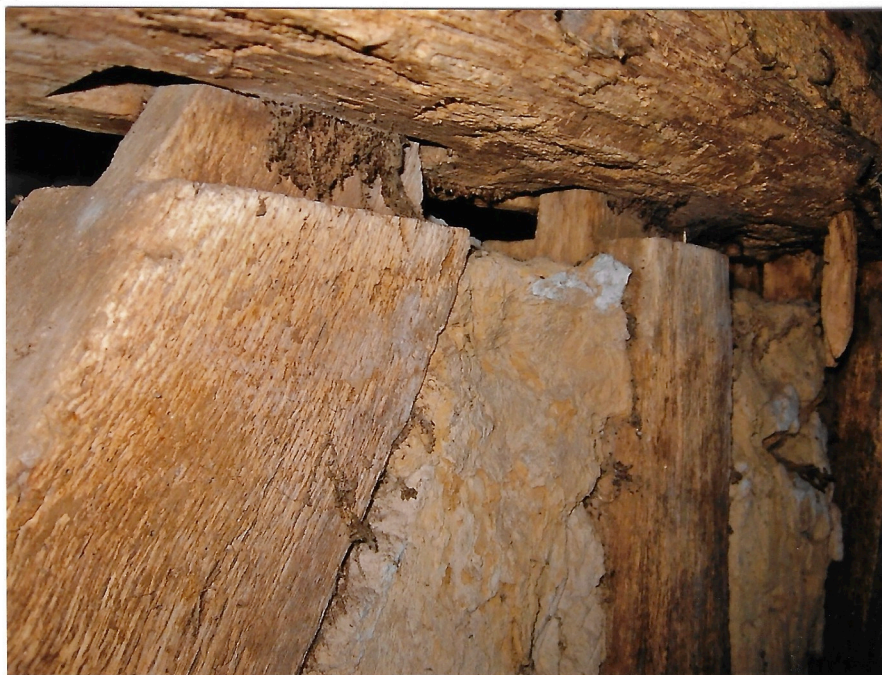
doppelseitige Zapfenbrust der Fachwerkbalken

double-sided tenon breast of the truss beams

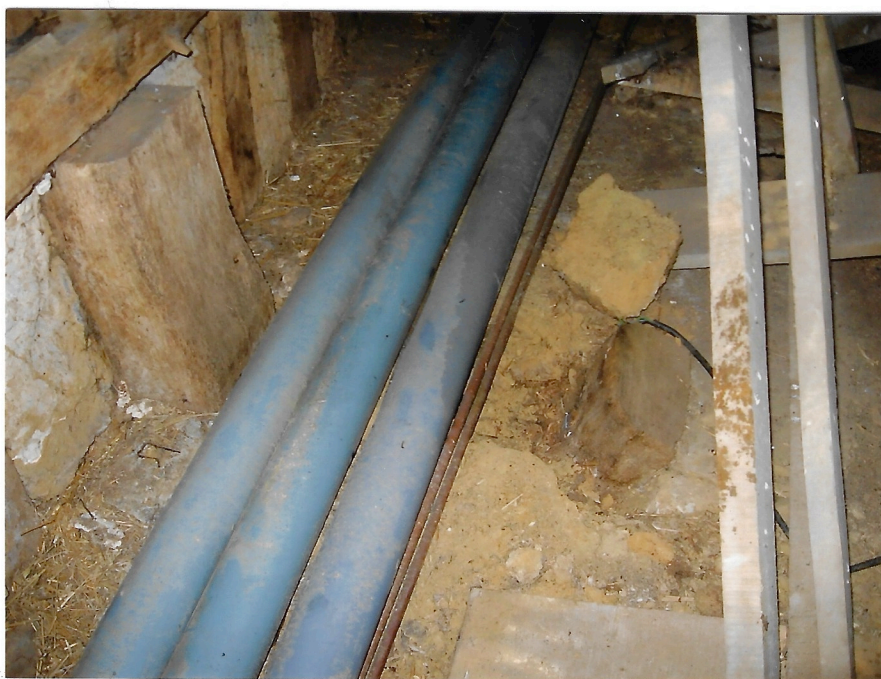
Reste der Hauptsparren im Deckenbalken des Wohnraum

Remains of the main rafters with ceiling beams in the living room

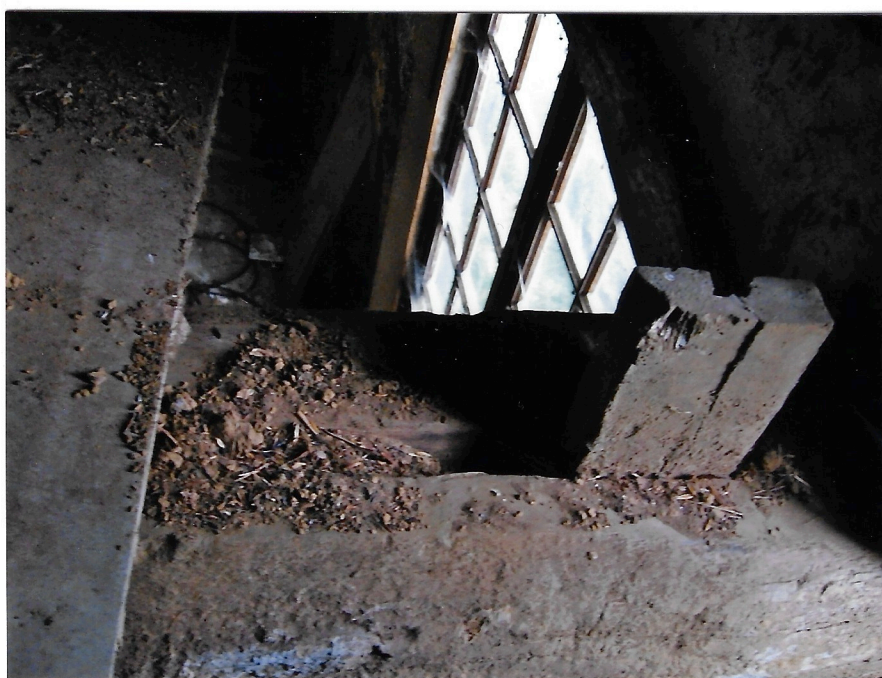
Zapfenloch im Deckenbalken zur Aufnahme der Hauptsparren

Tenon hole in the ceiling beam to accommodate the main rafters

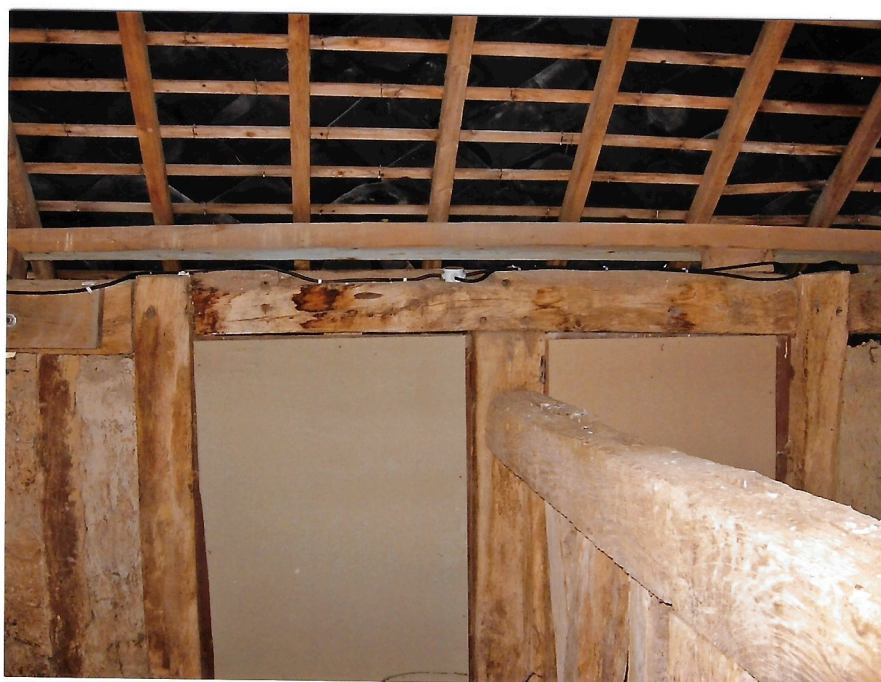
durchlaufende Ständer in der hofzugewandten Seite
Continuous Post on the side facing the courtyard

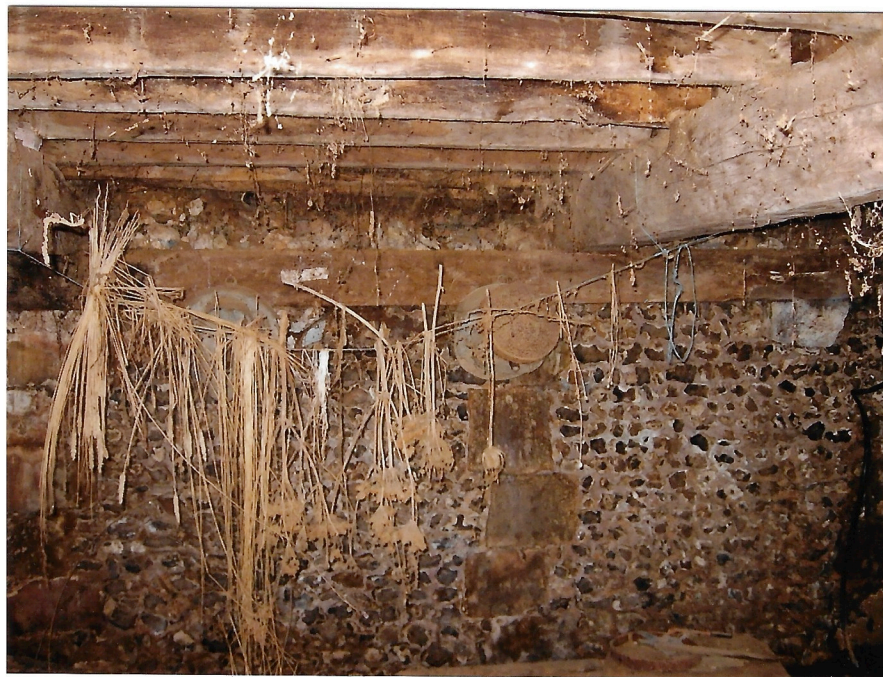
Balkenauflage im Keller

Beam support with basement

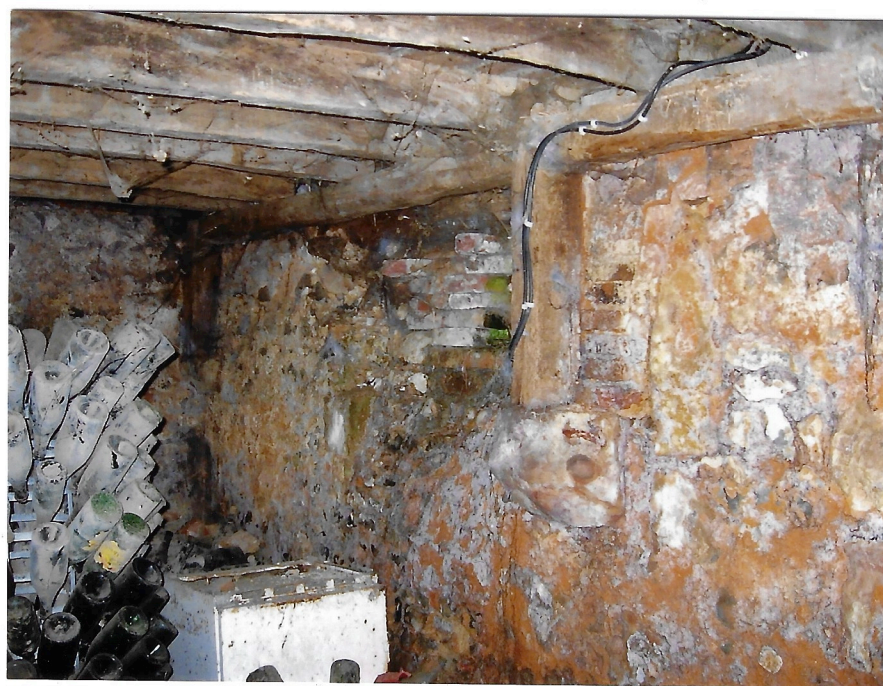
Balkenauflage im Keller

Beam support with basement

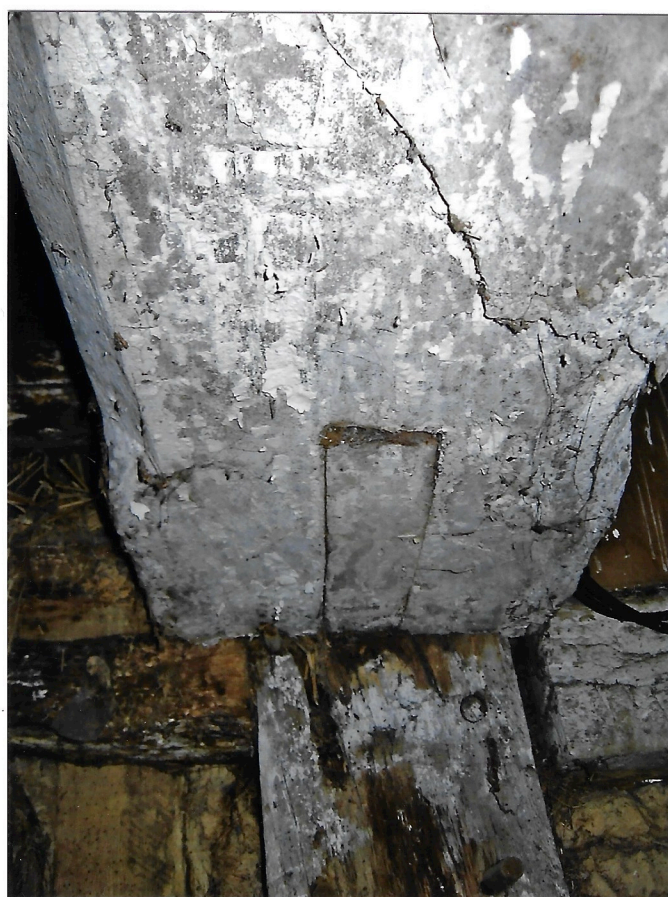
Reparatur am Deckenbalken im Stall

Evaporation off a main beam in the stable

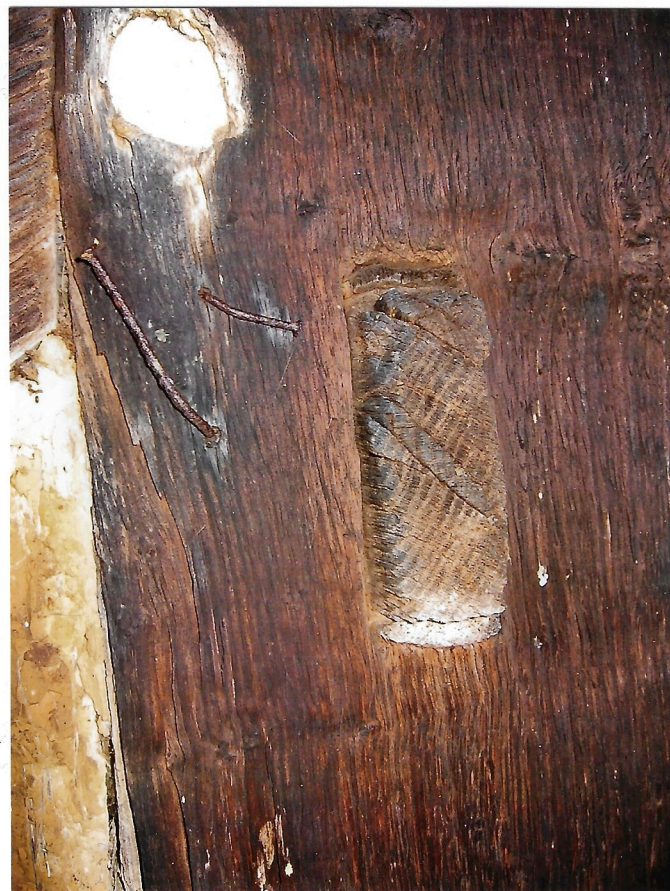
Zapfen an der hofabgewandten Seite mit unbekannter Nutzung
